**DEPARTMENT OF TRANSPORTATION****DIVISION OF ENGINEERING SERVICES**

Quality Assurance and Source Inspection

Contract #: 04-0120F4Cty: SF/ALA Rte: 80 PM: 13.2/13.9File #: 69.28**WELDING INSPECTION REPORT****Resident Engineer:**Siegenthaler, Peter**Address:** 333 Burma Road**City:** Oakland, CA 94607**Report No:** WIR-019055**Date Inspected:** 02-Jan-2011**Project Name:** SAS Superstructure**OSM Arrival Time:** 700**Prime Contractor:** American Bridge/Fluor Enterprises, a JV**OSM Departure Time:** 1900**Contractor:** Zhenhua Port Machinery Company, Ltd (ZPMC), Changxing Island **Location:** Shanghai, China**CWI Name:** Liu Hua Jie**CWI Present:** Yes No**Inspected CWI report:** Yes No N/A**Rod Oven in Use:** Yes No N/A**Electrode to specification:** Yes No N/A**Weld Procedures Followed:** Yes No N/A**Qualified Welders:** Yes No N/A**Verified Joint Fit-up:** Yes No N/A**Approved Drawings:** Yes No N/A**Approved WPS:** Yes No N/A**Delayed / Cancelled:** Yes No N/A**Bridge No:** 34-0006**Component:** Orthotropic Box Girder( OBG)**Summary of Items Observed:**

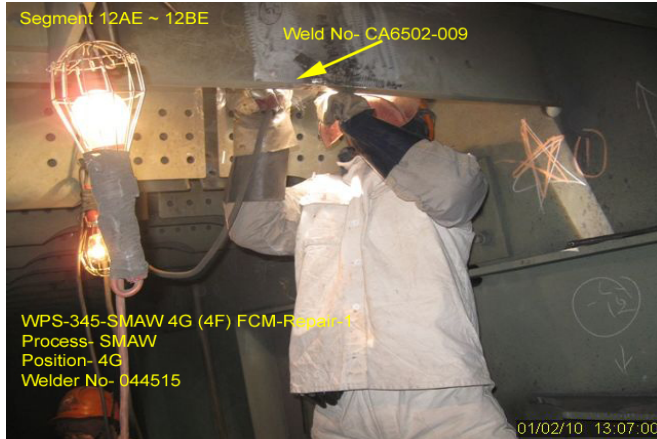
This QA Inspector observed ZPMC qualified welding personnel identified as 044515 perform Shielded Metal Arc Welding (SMAW), weld joint identified as CA6502-009; located On Orthotropic Box Girder (OBG) Deck Plate to Deck Plate Transverse Splice CJP Weld; The Critical Welding Repair Report (CWRR) was B-CWR2634. ZPMC Quality Control (QC) is identified as Mr. Wang Li Yang. The welding variables recorded by QC appeared to comply with applicable WPS-345-SMAW 4G (4F) FCM-Repair-1. See attached photo for further details.

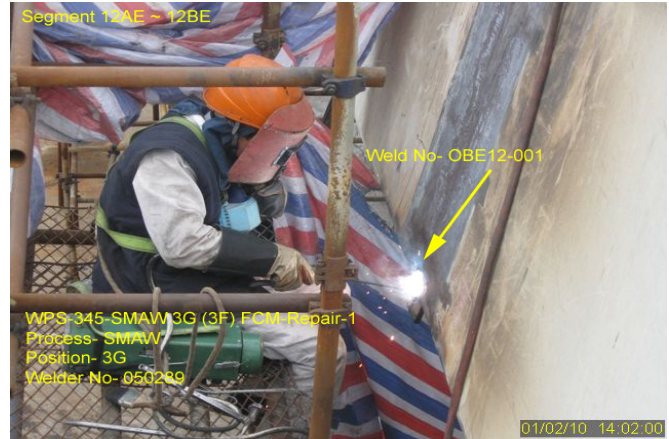
This QA Inspector observed ZPMC qualified welding personnel identified as 050289 perform Shielded Metal Arc Welding (SMAW), weld joint identified as OBE12-003; located On Orthotropic Box Girder (OBG) Edge Plate to Edge Plate Transverse Splice CJP Weld; The Welding Repair Report (WRR) was B-WR19745. ZPMC Quality Control (QC) is identified as Mr. Wang Li Yang. The welding variables recorded by QC appeared to comply with applicable WPS-345-SMAW 3G (3F) FCM-Repair-1. See attached photo for further details.
